PB91-916301  
NTSB/RAR-91/01

## RAILROAD ACCIDENT REPORT

DERAILMENT OF  
SOUTHEASTERN PENNSYLVANIA  
TRANSPORTATION AUTHORITY (SEPTA)  
COMMUTER TRAIN 61  
PHILADELPHIA, PENNSYLVANIA  
MARCH 7, 1990

ADOPTED: APRIL 23, 1991  
NOTATION: 5281C

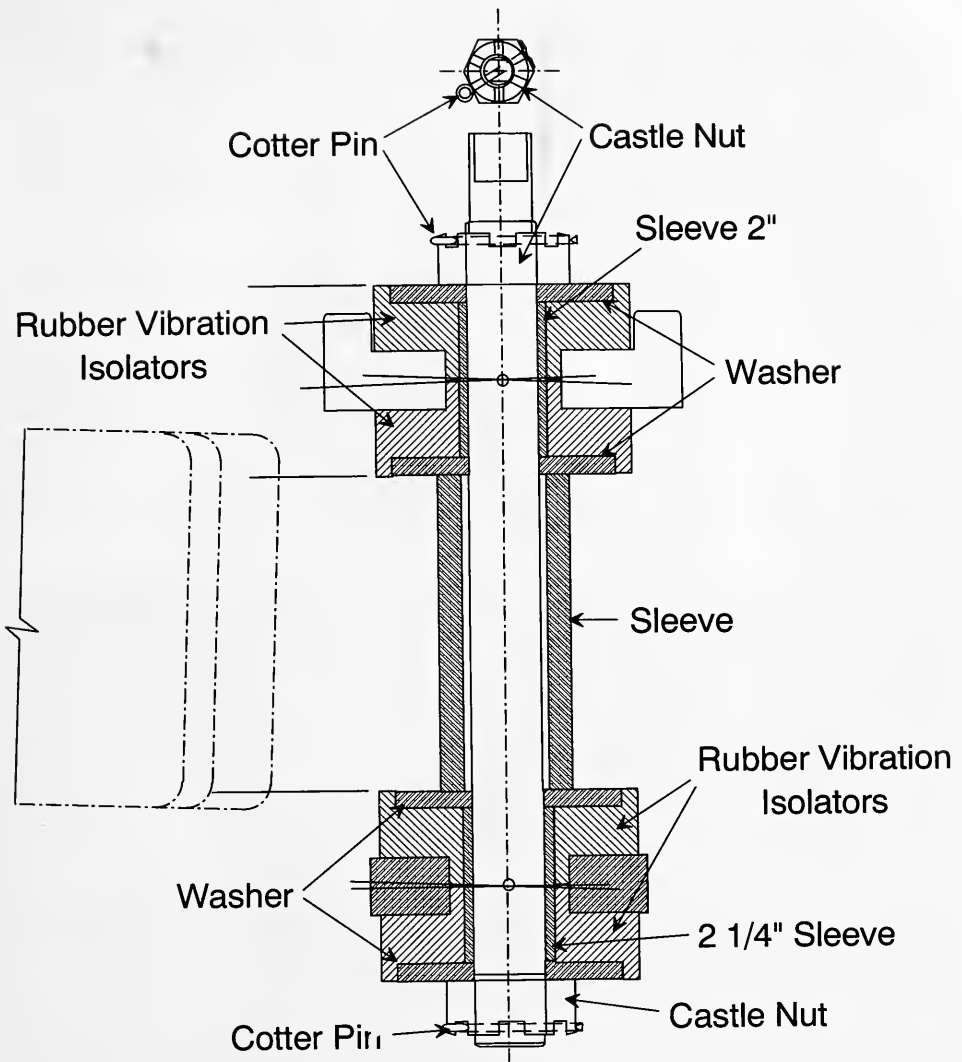
When the Safety Board reviewed SEPTA mechanical drawing No. C-1004 (see figure 6), it found that the upper part of No. 46F was a shorter metal sleeve than was the sleeve in the lower part of No. 46F. However, the drawing showed no washer between the lower half of the upper vibration isolator assembly (46D) and the metal sleeve between the upper and lower isolator assemblies (46G). This is in conflict with the Budd Car Company's original drawing in which a washer was shown at this location. (See figure 7.) Safety Board investigators found that both the upper and lower metal sleeves on the vertical support bolt from car 817 were 2 inches long, and SEPTA officials testified that 2-inch sleeves had been used for both the upper and lower vibration isolator assemblies for as long as they could remember.

Figure 7.--Budd Car Company vertical support bolt drawing.
